# BELZONA SHM-12 POSITIVE GRIP SYSTEMS USED TO RE-LAG DRIVE PULLEY

ID: 5188

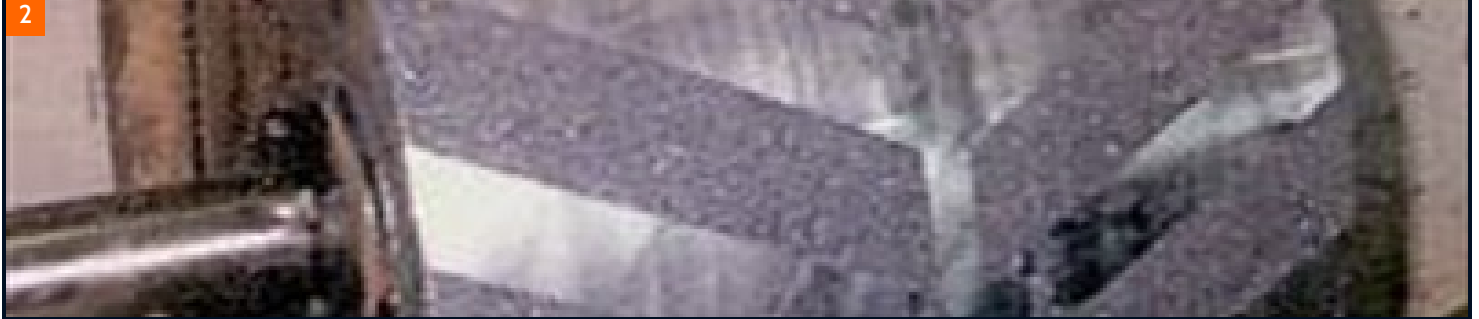
1. The original lagging has been removed and the steel surface ground to provide a rough profile onto which the Belzona product is applied
2. Completed application. In this instance a chevron type pattern was employed to ensure that rain water (Outside application) would be swept to the outer circumferences of the roll.

Application carried out in accordance with Belzona Know-How System Leaflet SHM-12

The Belzona product is applied directly to the steel roll. It also provides a far higher degree of positive traction increasing belt life by reducing slippage.
