# BELZONA REPAIRS RUBBER LINED SLURRY PUMP

ID: 5189

Rubber lining on a slurry pump

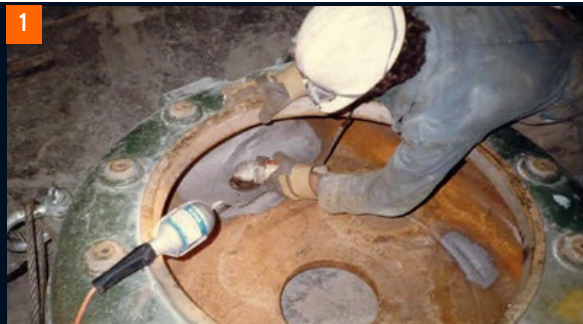
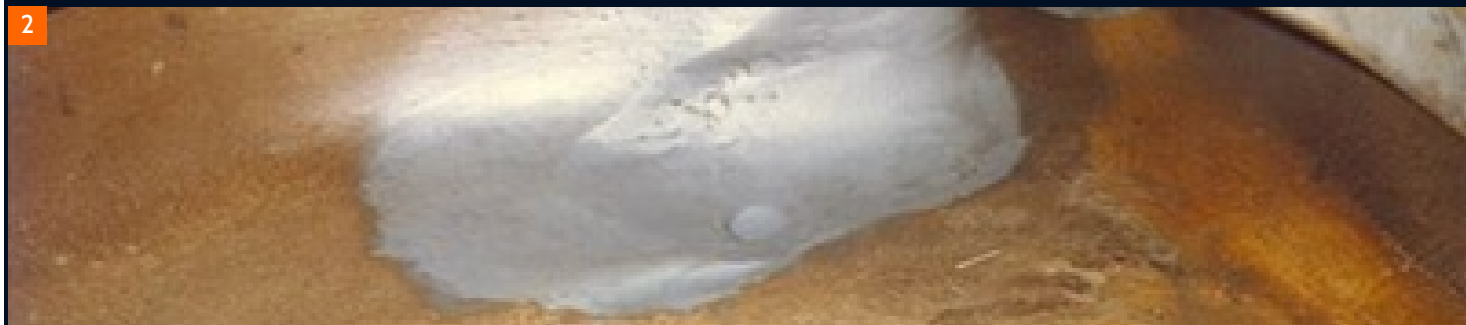
A hole had worn into the rubber lining in a number of areas from the coal slurry and had started to erode the metal casing.

1. Preparation of the damaged areas in progress
2. Preparation completed
3. Rubber liner rebuilt

Application carried out in accordance with Belzona Know-How System Leaflet SHM-11

Belzona 2111 (D&A Hi-Build Elastomer)
