# BELZONA ELASTOMERS REPAIR CUT IN TIRE

ID: 5192

## PROBLEM

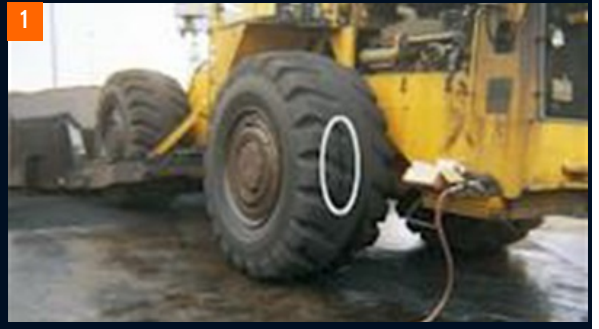
Tire on earthmoving equipment had been badly damaged.

1. View of equipment and the extent of the damaged area
2. Surface around the damaged area prepared and coated with Belzona 2911
3. Damaged area sealed and rebuilt with Belzona 2211
