# BELZONA REBUILDS WORN CAT D9 SPLINESHAFT ASSEMBLY

ID: 5194

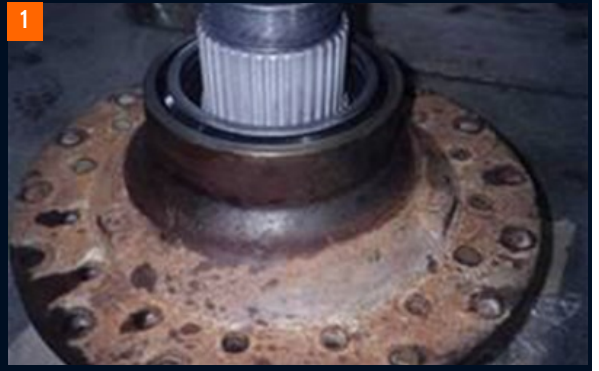
The main drive spline on D-9 cat had worn loose over many years of service.

1. View of worn spline shaft assembly
2. Belzona 1111 Super Metal applied to worn splines
3. Components reassembled
4. The main framework that the Spline assembly is being bolted to
