# BELZONA REPAIRS AND SEALS CRACKED TRANSMISSION CASING

ID: 5195

Repairing cracked and leaking transmission housing

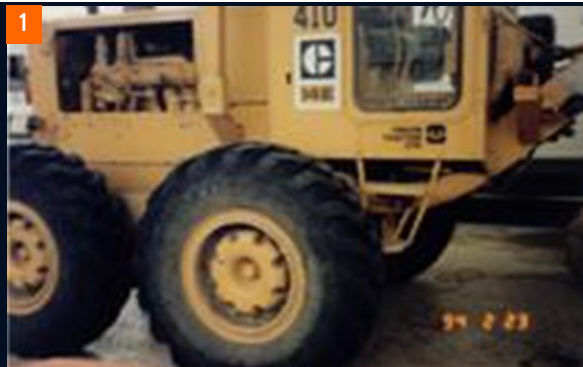
1. View of equipment
2. Crack "V" out and the surface area around it roughened
3. Belzona 1111 applied to the area around the repair
4. A reinforcement plate bolted over the uncured Belzona material to provide additional mechanical strength to the area.
