# BELZONA EXTENDS THE LIFE OF DAMAGED TIRE

ID: 5196

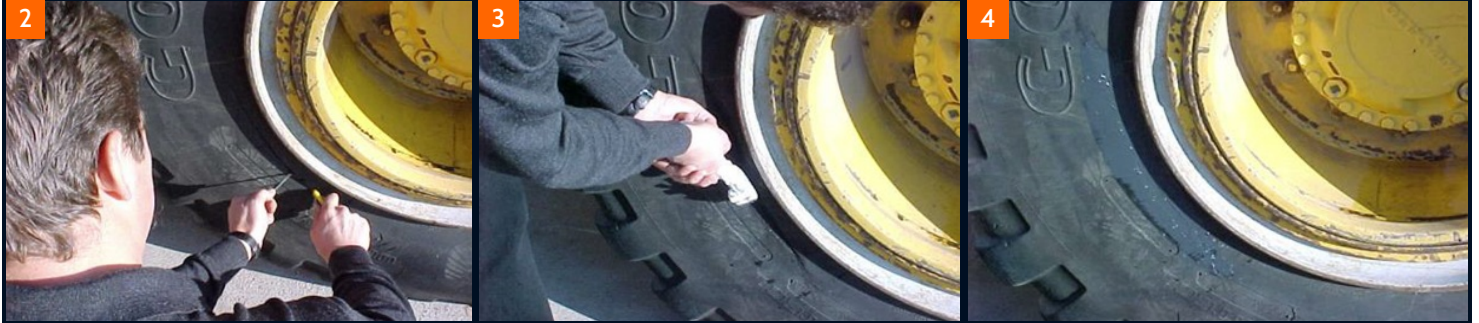
## PHOTOS

The side wall of a tire, close to the rim, had been cut by a stray piece of metal

1. Vehicle with damaged tire
2. Initial preparation underway with the removal of any loose material
3. The surface around the damaged area is prepared with a special roughing tool
4. Completed application.

Application carried out in accordance with a modified version of Belzona Know-How System Leaflet SHM-1. Surface around damaged area cleaned of loose road debris and roughen with a steel wire brush. Belzona 2911 (Elastomer QD Conditioner) was applied prior to Belzona 2211 to ensure proper adhesion.
