# BELZONA 2311 (SR ELASTOMER) USED FOR EMERGENCY REPAIRS

ID: 5197

Belt repair in gravel pit

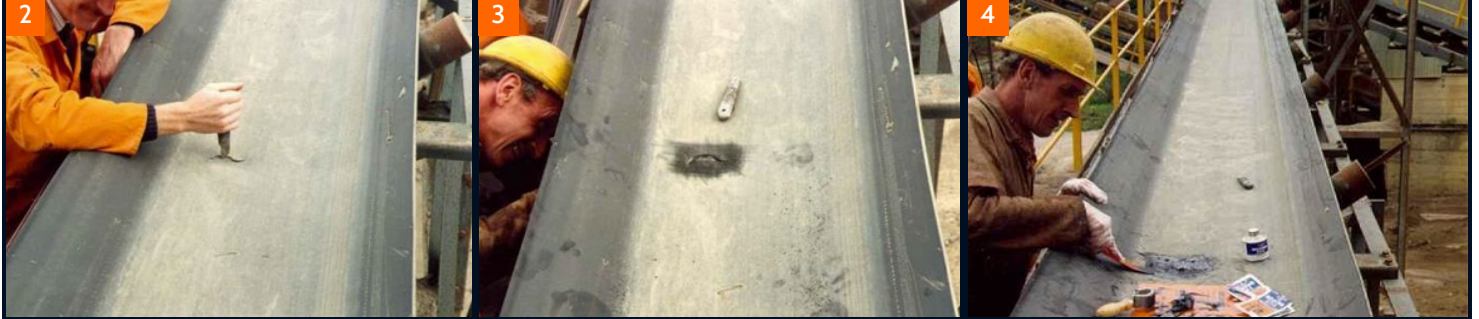
A small cut had developed in a section of the belt

1. View of the cut in the belt
2. Initial preparation underway
3. The loose piece of belting has been cut away and area around it roughed up with a special roughing tool
4. Repair in progress

Application carried out in accordance with a modified version of Belzona Know-How System Leaflet SHM-1

The use of Belzona 2311 allowed the yard to repair the damage before it became more serious. The quick setting properties of the repair material also allowed the repair to be completed during a lunch break ensuring no downtime.
