# BELZONA 1811 CERAMIC CARBIDE EXTENDS LIFE OF PUMP CASING

ID: 5198

Erosion on gravel slurry pump

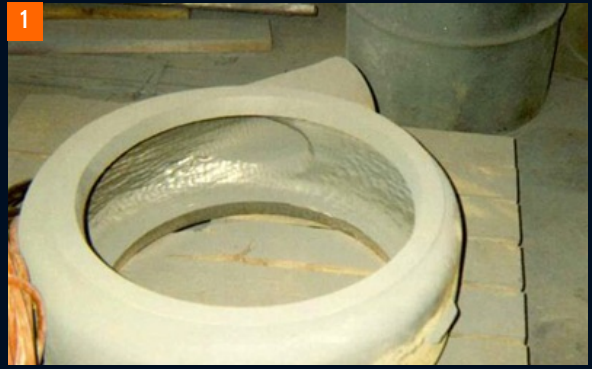
1. View of Pump
2. Close-up of pump showing extent of erosion
3. The internal surfaces of the pump casing are protected with Belzona 1811

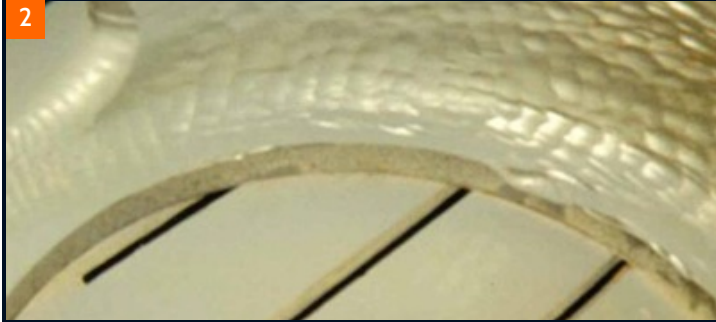
Pumping drainage water from a gravel pit has a high percentage of entrained solids causing major erosion damage to pumps
