# BELZONA 2200 SERIES ELASTOMERS REPAIR SPLIT CONVEYOR BELT

ID: 5199

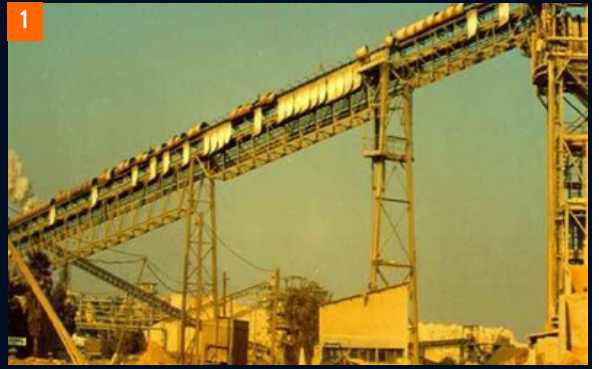
A mechanical breakdown had caused the belt to be split over a length of approximately 100 feet.

1. Conveyor system in need of repair
2. The damaged portions of the belt were held together using mechanical fasteners
3. Close-up of fasteners and the prepared belt surfaces conditioned with Belzona 2911
4. The completed repair
