# BELZONA ELASTOMERS USED TO PROTECT CONVEYOR BELT CLIPS

ID: 5200

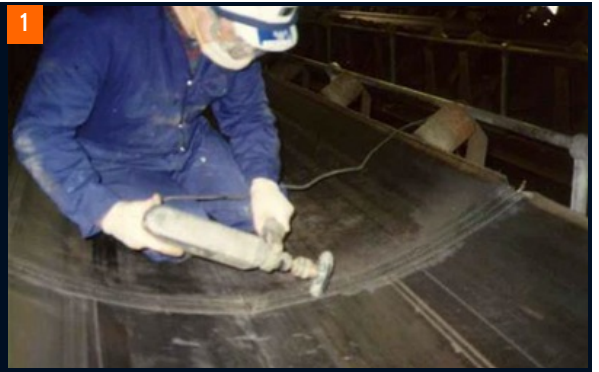
The fine gravel was constantly wearing out a clip joint

1. Preparation of the clip joint and damaged area in progress
2. Preparation completed
3. Area masked off and the prepared area conditioned with Belzona 2911 (QD Conditioner)
4. Completed application.

The use of the Belzona procedures enabled the clip joint to be permanently protected and the damaged section of the belt repaired at the same time
