# BELZONA REBUILDS ERODED METAL AND DAMAGED LINER

Lining repair of a sand and gravel hopper

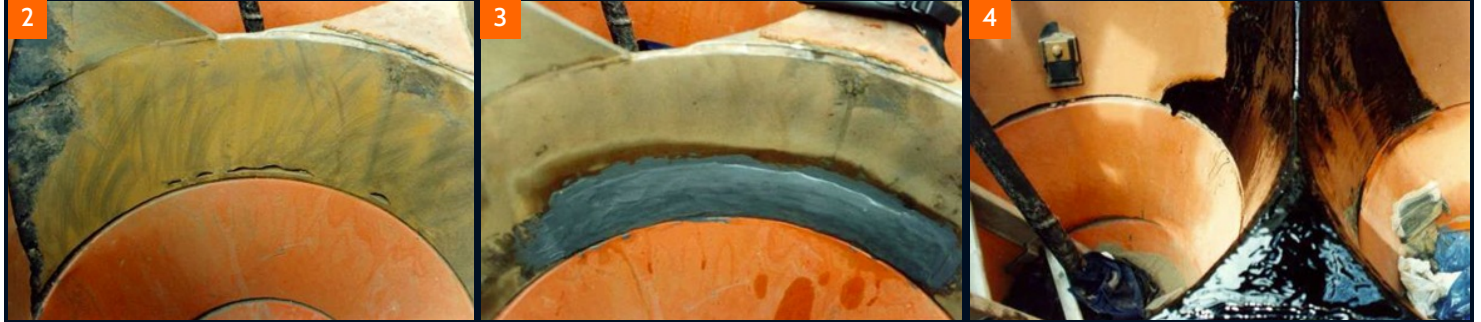
The abrasion resistant lining of the hoppers had been damaged allowing corrosion to develop underneath it

1. Sand and Gravel Hopper
2. View of the damaged liner
3. Damaged liner stripped from the affected areas
4. After preparing the metal surfaces the eroded area was rebuilt with Belzona 1311
