# BELZONA 1000 SERIES PRODUCTS RE-SEAT WEAR PLATES

ID: 5202

Worn Bradley Pulverizer

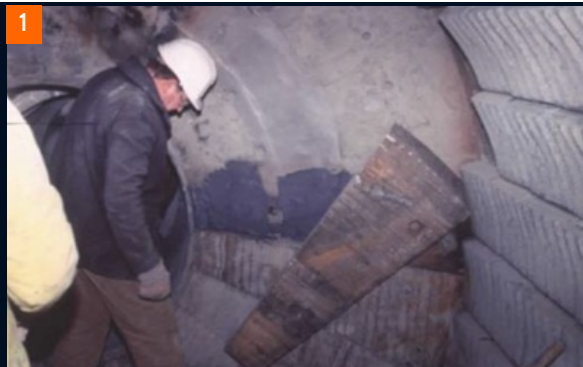
The base plate of the Bradley Pulverizer had worn unevenly making it difficult to effectively reinstall new wear plates

1. Belzona 1121 has been applied to all the worn areas, while a release agent has been applied to the underside of the new wear plates to ensure that they are easily removed when required
2. Installation in progress
3. Completed application.

Application carried out in accordance with a modified version of Belzona Know-How System Leaflet GSS-8

Because of the crushing forces involved, it is imperative that wear plates be supported 100% across their surface area. Failure to achieve this would induce early cracking of these plates necessitating an unscheduled shutdown.
