# BELZONA 1111 SUPER METAL SOLVES PROBLEM QUICKLY

ID: 5203

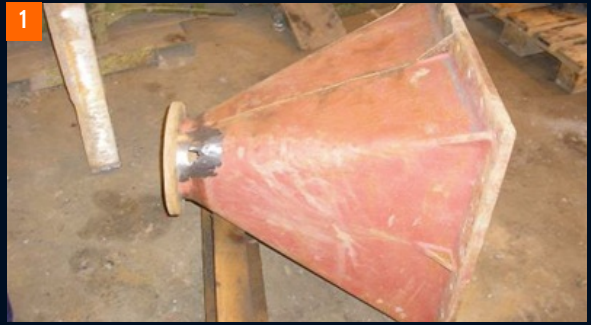
Due to the continuous flow of abrasive aggregate and vibration the transition piece would wear out and crack.

Cracked hopper

1. The area to be repaired was ground to a clean rough surface with a mechanical grinder
2. Repair in progress
3. Completed repair.

The use of Belzona to bond a patch over this problematical section proved to be quicker and easier to do than welding. The repair also lasted well beyond the standard welded repair.
