# BELZONA REBUILDS DIVERTER VALVES FOR CEMENT PLANT

ID: 5204

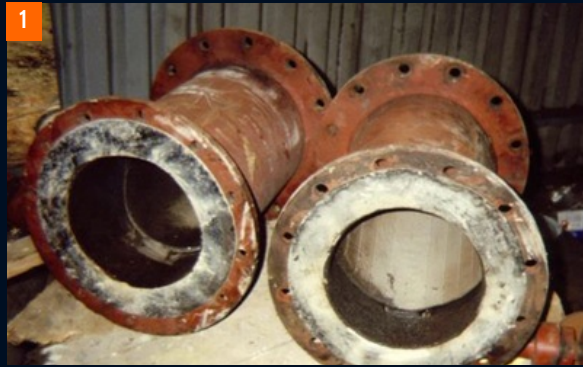
The seating area of the diverter valve would wear.

Two valves in workshop waiting to be rebuilt Worn areas where valve flap sits against the valve body are marked out with chalk and rebuilt Rebuilt valve. Area ahead and behind valve flap were rebuilt
