# BELZONA EXTENDS LIFE OF JET VALVE

ID: 5205

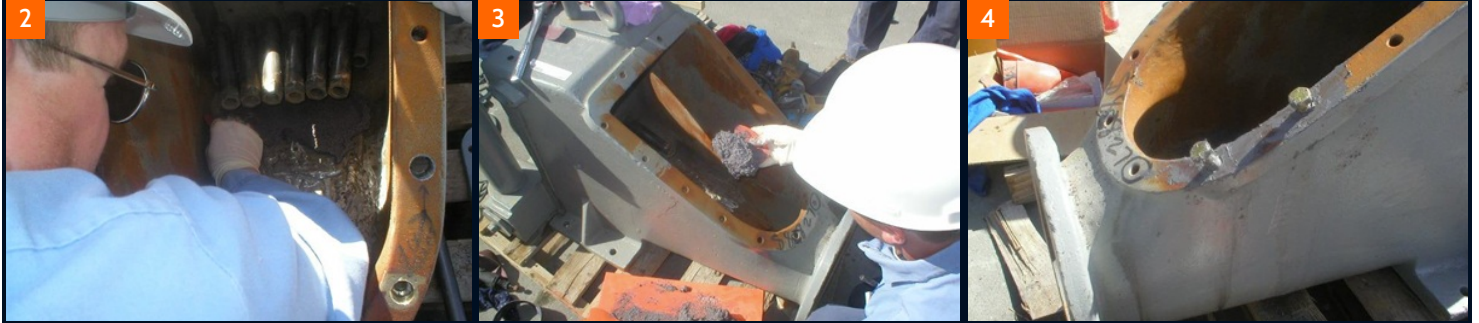
These jet valves would generally last about 5-6 months before they would wear through from the air / sand / water mixture pumped through them.

1. View of the volute area
2. Showing preparation in progress of the eroded area
3. Application of the Belzona material in progress
4. Application of the Belzona 1812 in progress

Application carried out in accordance with Belzona Know-How System Leaflet CEP-1

These air valves cost approximately \$ 20,000.00 each. The Belzona repair cost less than 5% of the original cost and showed little signs of wearing out after a 9 month inspection.
