# BELZONA REPAIRS A CONDENSER TANK IN A FREEZER ROOM

ID: 5207

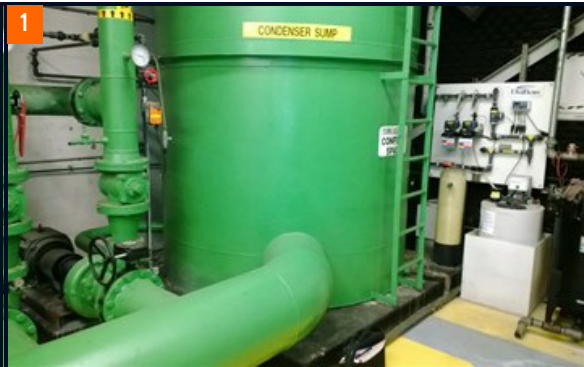
1. Overview of the sump tank
2. Evidence of the leak
3. Weld seams and pittings filled with Belzona 1111
4. Overcoating with Belzona 5811

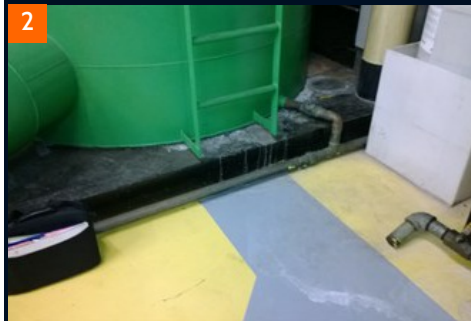
The customer had a leaking sump tank on the floor of a frozen food warehouse, creating hazardous conditions.
