# BELZONA PROTECTS STRUCTURAL STEEL OF A PAPER MACHINE

ID: 5208

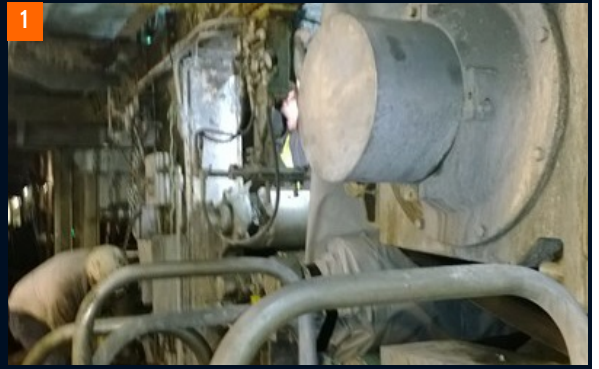
Structural steel on a section of a Valmet paper machine press.

1. Section of paper machine press
2. Paper machine name plate with corrosion
3. Close-up view of corrosion
4. Completed application

Hand tools, such as needle guns and grinders, were used for surface preparation before smoothing with Belzona 1121 and overcoating with Belzona 5811. The application was carried out with a modified version of Belzona Know-How System Leaflet TCC-5.

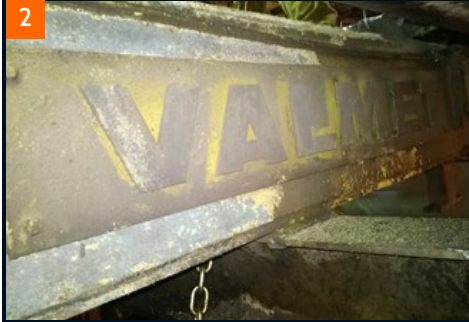
The paper machine structural steel was severely corroded and in need of corrosion protection.
