# BELZONA REPAIRS BEARING SADDLE SUPPORT

ID: 5209

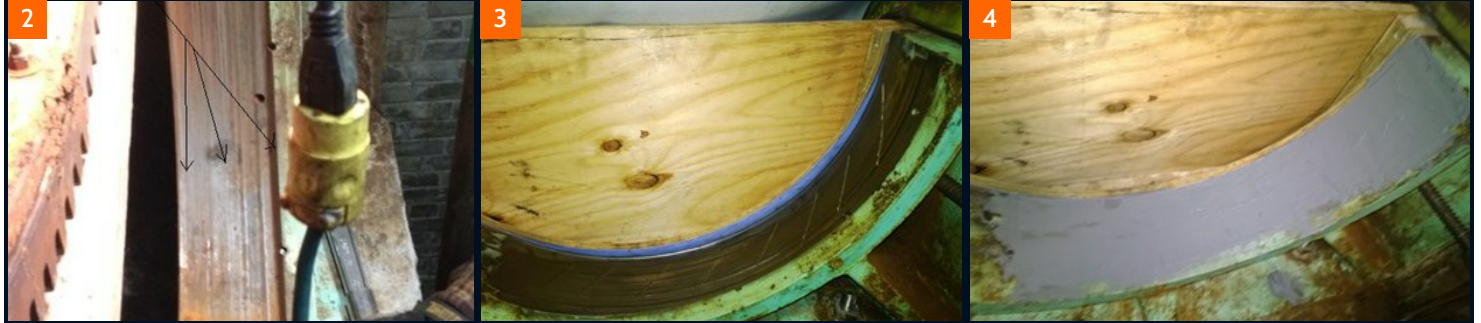
## PHOTOS

Severe metal loss from entrained solids in flowing water. During inspection, it was noted that a water screen bearing was grooved from abrasion. Upon removal for repair with Belzona 1111, it was further found that the support saddle was severely worn (3/4" +/-) under the bearing itself.

1. Grooved bearing surface
2. Support saddle showing deep grooves
3. Plywood & gasket former
4. Completed application

Hand tools, such as grinder, were used to prepare the surface. A plywood former was built to provide the profile depth. The application was carried out in accordance with a modified version of Belzona Know-How System Leaflet ENC-3b.
