# BELZONA COATS FILTER PRESS TRAYS

ID: 5211

Filter press trays

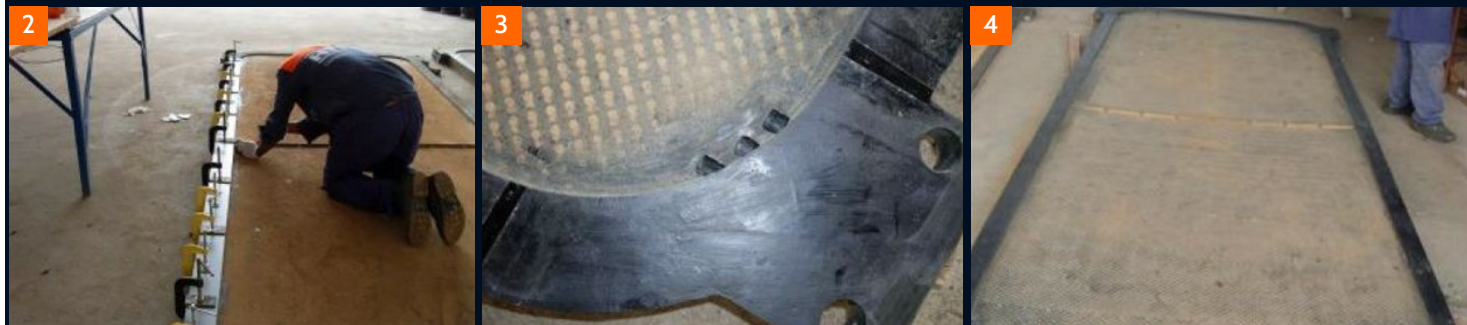
## PHOTOS

The trays of the filter press (4 parts) showed abrasion wear, which caused inefficiency in the production process, increased the humidity of the final product and the use of compressed air, and wore out the other components of the filter. Fluid: water and ore at room temperature ( $\leq 40^{\circ}\text{C}$ ).

1. Wear on edges of the rim
2. Side of the tray with a mold
3. Edges of the tray after coating with Belzona 2131
4. Tray repaired/coated with Belzona 2131

The application was carried out in accordance with Belzona Know-How System Leaflet GSS-1. Surfaces were prepared by dry abrasive blasting. After cleaning, the surfaces of worn areas were repaired with Belzona 2131. For the elastomer application molds were made and Belzona 9411 was applied to facilitate their removal after initial cure of the elastomer.

Belzona 2131 offered flexibility, abrasion and hardness resistance. The repair of the existing trays eliminated the accumulation of scraps on the area and reduced maintenance costs (part replacement).
