# BELZONA REPAIRS AND PROTECTS DAMAGED DRAINS

ID: 5212

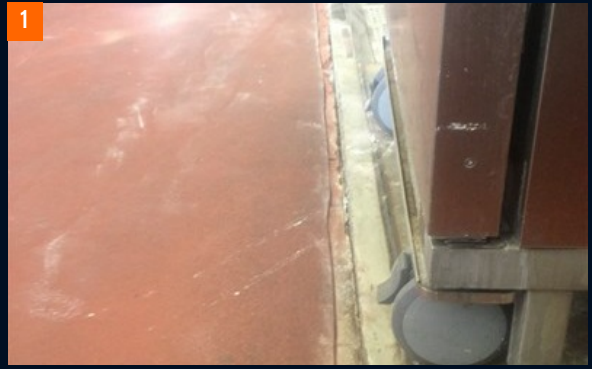
The edges of the floor drain were breaking due to a combination of chemical attack and physical damage.

1. Floor drain prior to application
2. Preparation in process
3. Application in process
4. Completed application
