# BELZONA PROTECTS CHILLER TUBE SHEET

ID: 5213

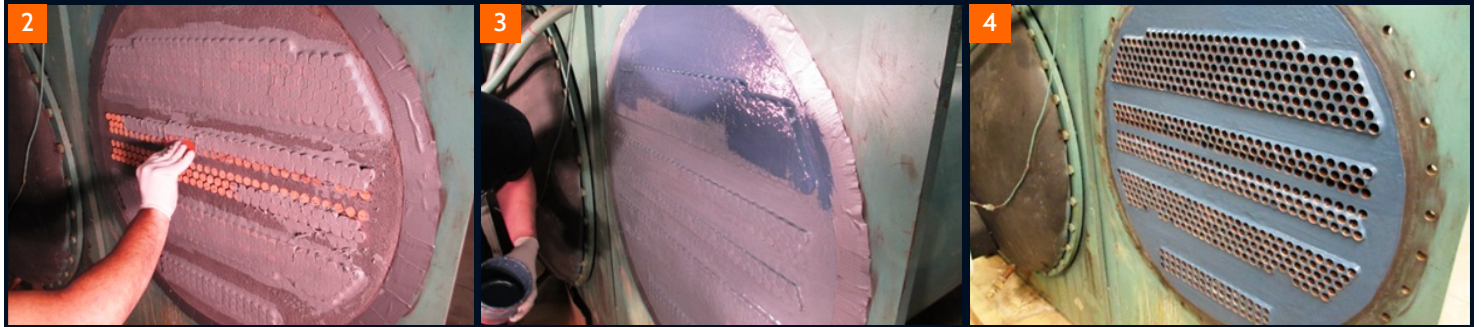
The chiller tube sheet was suffering from corrosion due to bi-metallic corrosion.

1. Prior to application
2. Application in process
3. Application in process
4. Completed application

The application was carried out in accordance with Belzona Know-How System Leaflet HEX-1 for repairing eroded-corroded tube sheets. The surface was prepared by grit blasting and the surface was washed with Belzona 9111 to remove all residual blasting debris. The tubes were plugged with corks and Belzona 1111 was applied to the area using an applicator. The second coat of Belzona 1321 was applied with an applicator in accordance with the Belzona Instructions For Use.
