# BELZONA SAVES THOUSANDS OF DOLLARS WITH HOUSING REPAIR

ID: 5215

Rear differential housings of a large fleet of trucks.

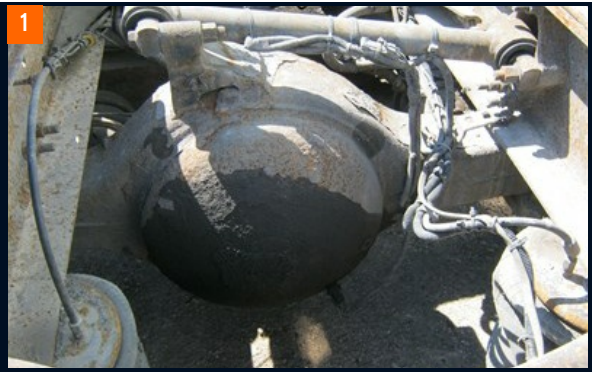
A large fleet of trucks were aging, which was causing severe corrosion of the rear differential housings and leaking oil.

1. Prior to application
2. Preparation complete
3. Complete application
