# BELZONA REDUCES DOWNTIME WITH SHAFT REPAIR

ID: 5216

Bearing failure caused severe scoring to shaft.

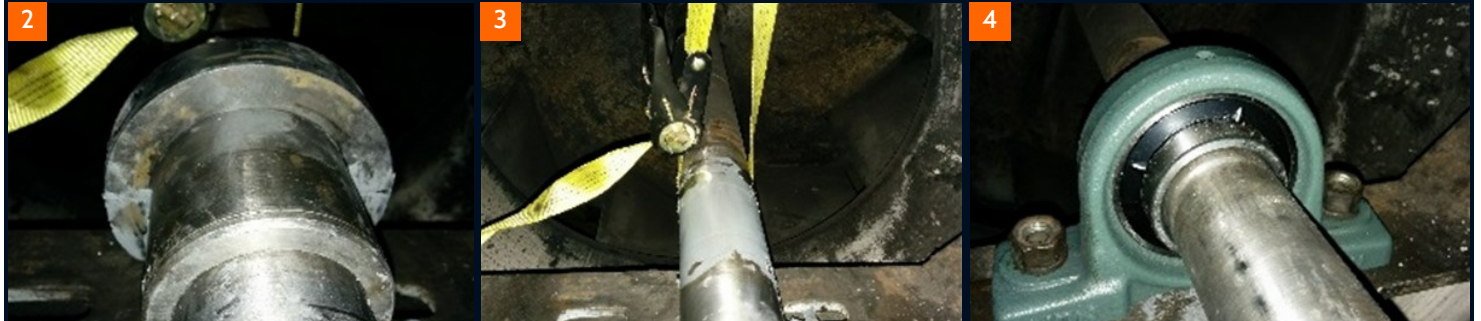
1. Prior to application
2. Preparation in process
3. Completed application
4. Completed application in service

The application was carried out in accordance with Belzona Know-How System Leaflet FBC-13 for repairing shafts by forming techniques. The surface was prepared by mechanical grinding and cleaning with Belzona 9111 to remove all residue. The former's interior was prepared with Belzona 9411. Belzona 1111 was applied to the shaft and former, and the former was installed on the shaft. After curing, the former was removed and the shaft was checked for fit tolerance.
