# EXPANSION JOINTS REPAIRED WITH BELZONA

ID: 5217

Expansion joints at a warehouse.

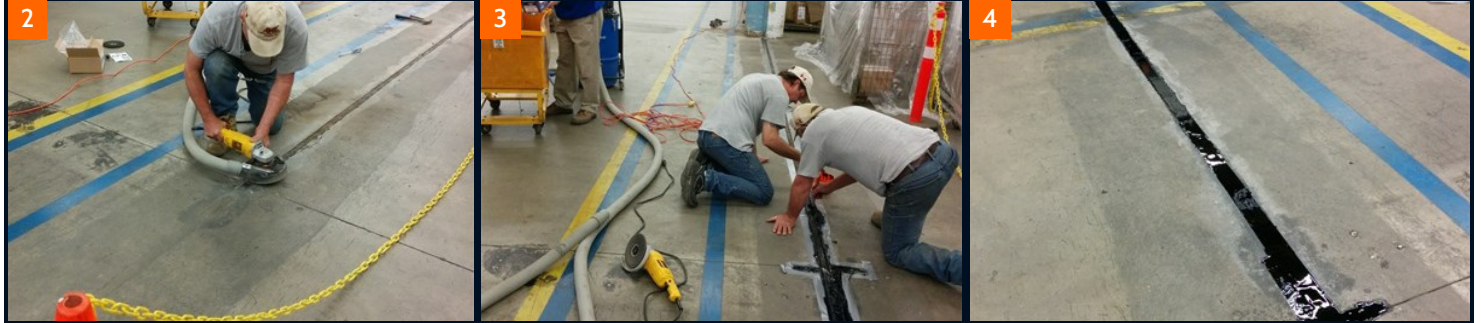
The previous joint had failed, and the area of the floor was closed off to fork lifts and handling equipment.

1. Prior to application
2. Preparation in progress
3. Application in progress
4. Completed application

The application was carried out in accordance with Belzona Know-How System Leaflet FPA-6 for replacing expansion joint sealants. The concrete was prepared by removing the existing expansion joint by hand and with a hand grinder, together with a vacuum to drastically reduce the dust to clean the concrete. The application area was taped and Belzona 2911 was applied over the entire joint area. Then Belzona 2131 was poured into the joint. The tape was removed after application.
