# BELZONA SAVES A BROKEN COMPRESSOR CASING

ID: 5218

A broken compressor casing

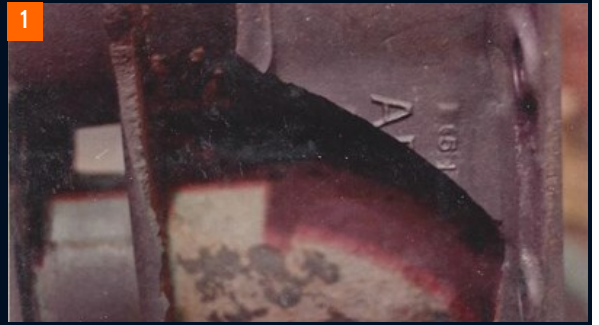
Freezing water damaged WWII compressor jugs. No replacement available.

1. Compressor jugs showing broken casting
2. Ready for application of Belzona 1111 with studs holding the broken piece in place
3. Complete with reinforced Belzona 1111

The application was carried out in accordance with Belzona System Leaflet ENC-1. Drilled, tapped and studs to hold the broken piece were put in place. The casing was coated with Belzona 1111, Reinforcement Sheet was embedded, and another coat of Belzona 1111 was applied.
