# BELZONA SAVES HEAT EXCHANGER FROM COSTLY REPLACEMENT

ID: 5219

Heat exchanger covers.

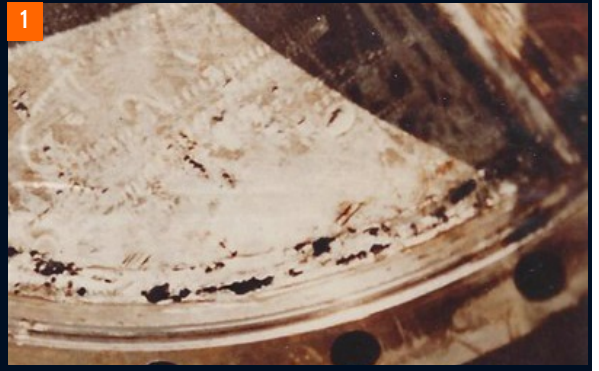
All ten heat exchangers had been replaced just one year ago. The covers were stainless steel but were welded with a carbon steel rod, setting up electrolysis. Replacements would take more than 3 months to build and a cost of downtime at \$70,000.00 per day. With Belzona, all ten were rebuilt in just seven days. They were opened one year later and the heat exchangers were found to be in perfect condition.

1. End cover showing electrolysis
2. Close up of damage
3. & 4. Completed application on end cover

The application was carried out in accordance with Belzona Know-How System Leaflet HEX-2.
