# BELZONA SAVES CENTRIFUGAL PUMP FROM REPLACEMENT

ID: 5221

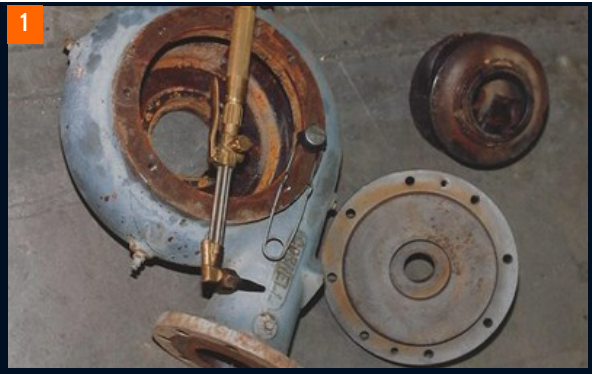
Erosion/Corrosion was eating away this water pump at a fruit processing company, causing it to pump less water than was required. It was then pulled from the scrap pile.

1. Damaged Cornell pump
2. Coating of impeller
3. Coating of pump casing
