# BELZONA 3411 SOLVES CORROSION ISSUE FOR A CHEMICAL PLANT

ID: 5222

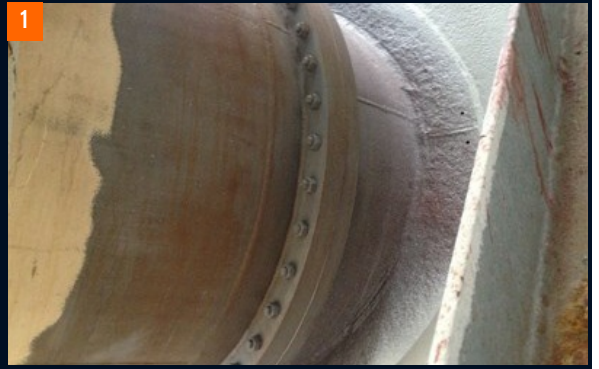
1. 52" Flange prepared for application, grit blasted
2. First coat of Belzona 3411
3. Second coat of Belzona 3411
4. Final sideview of flange
