# BELZONA REPAIRS A TIRE OF A DUMP TRUCK

ID: 5223

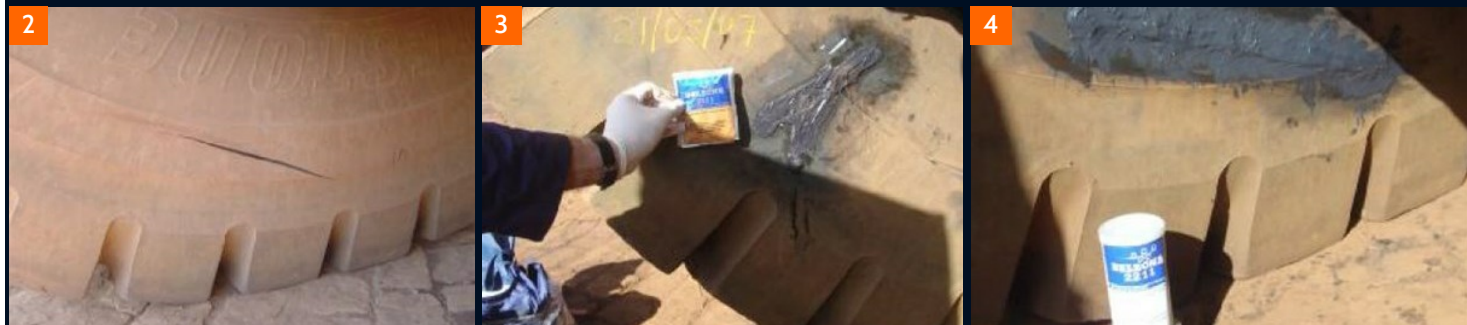
## PHOTOS

One of the tires of the dump truck had two lateral cuts, which reached the metal mesh and may have been caused by stone impact during movement. It was necessary to repair the affected area in order to prevent the cut from expanding and the tire to become useless before the end of its useful life. Lateral cuts measured 130 mm and 500 mm in length and 40 and 60 mm in depth.

1. One of the cuts on the side of the tire
2. Another cut on the side of the tire
3. Application of Belzona 2311
4. Application of Belzona 2211

The application was conducted according to Belzona Know-How System Leaflet SHM-9. The lateral cut was opened and all the loose rubber was removed, reaching the inner liners, without exacerbating the problem. After scarification of the rubber, cleaning of the cut and application of Belzona 2911 conditioner, two repairs were made: the first one with the application of Belzona 2311 and the second one with the application of Belzona 2211.

The Belzona repair remained adhered with excellent performance for more than 60 days (more than 1,500 hours), which was the time period requested by the client.
