# BELZONA REPAIRS SLURRY PUMP

ID: 5224

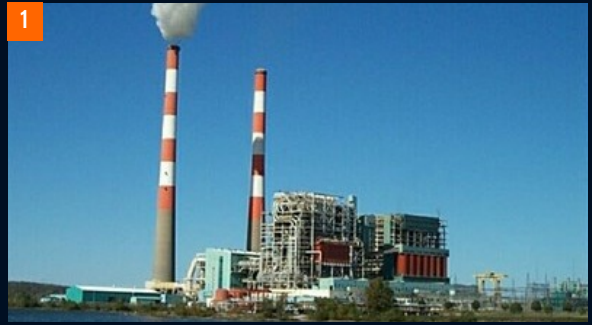
One of the plant's ash slurry pumps showed signs of severe erosion. Due to the extreme pitting and metal loss caused by entrainment, the plant would have resigned to discarding this pump and replacing it with a new one.

1. Plant site overview
2. Damaged pump prior to blasting
3. Blasted surface of pump
4. Completed application

Belzona offered a perfect alternative to replacing this stainless steel classifier pump. The application was carried out in accordance with Belzona Know-How System Leaflet SHM-11 using Belzona 1812.
