# BELZONA REPAIRS AND COATS PUMP CASE

ID: 5228

Pump case.

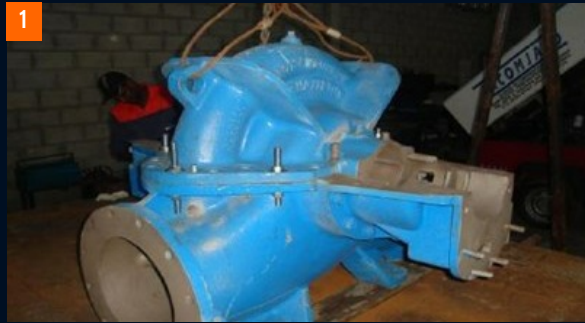
The equipment presented minor wear due to localized corrosion on the casing. It was necessary to restore the worn areas and apply a lining with excellent corrosion and high temperature resistance. The fluid consists of a caustic soda solution with few solids at a temperature of 81° C. Speed rotation: 1789 rpm.

1. Equipment assembled before the repair
2. Case refurbishment with Belzona 1111
3. Case refurbishment concluded with Belzona 1111
4. Service concluded, case lined with Belzona 1391

The repair and coating were carried out in accordance with Belzona Know-How System Leaflets CEP -3 & CEP-5. The surface was prepared by dry abrasive blasting at near white metal. After the surface preparation, Belzona 1311 was applied to rebuild the casing and Belzona 1111 was applied on the ring seating. After that, a single coat of Belzona 1391 was applied with a 600 to 750 µm thickness on the entire internal surface of the casing.
