# BELZONA, THE ALTERNATIVE TO WELDING IN DIFFICULT SITUATIONS

ID: 523

Five-meter diameter storage tank - carbon steel construction

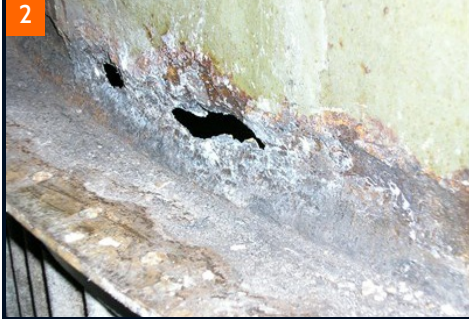
The tank was experiencing classic Corrosion Under Insulation caused by water ingress that was sitting on the lagging bands around the tank and soaking through the lagging. The problem was further exacerbated by the elevated temperature of the tank. Problem made still worse by the lining material being highly volatile requiring a Nitrogen shroud before and during any potential welding operations.

1. Scenic view of the tank farm.
2. Damage to tank wall.
3. The Belzona repair. After surface preparation to achieve profile the profiled plates were bonded in place with a fillet of Belzona material between them to allow excess water to run off.
4. Close up of repair area.
