# BELZONA PROTECTS CENTRIFUGAL PUMPS AGAINST EROSION-CORROSION

ID: 5230

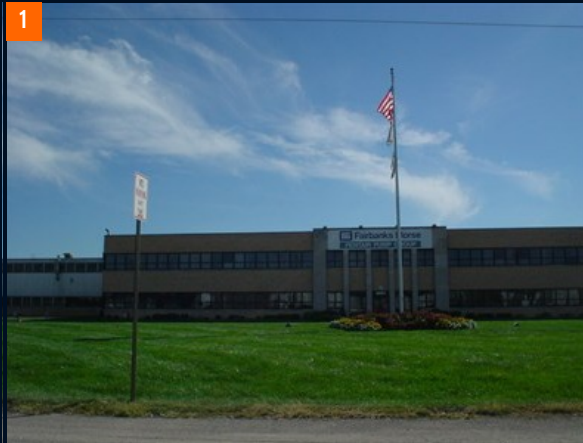
1. View of Fairbanks-Morse Pentair Pump Group
2. Centrifugal pump prior to application
3. Application in progress
4. Completed application

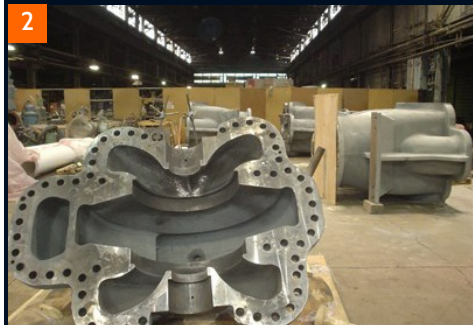
The project, consisting of ten new centrifugal pumps destined for a municipal facility, was experiencing difficulties in achieving consistent performance specifications due to the extremely irregular and rough castings.
