# BELZONA SAVES PUMP FROM REPLACEMENT

ID: 5231

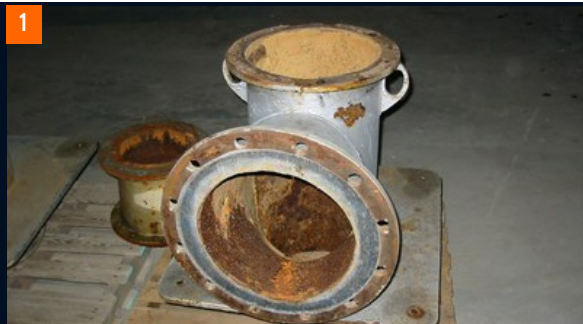
1. Overview of the pump
2. Sever corrosion damage to the pump
3. Completed application
4. Completed application

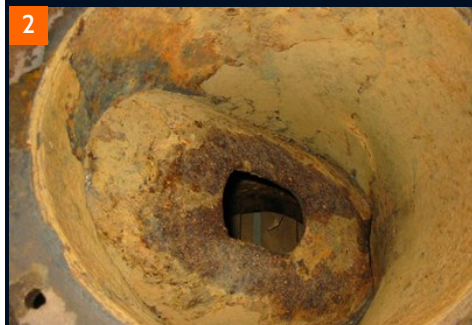
The pumps from one of this well-known amusement park's water rides had badly corroded with severe loss of metal. The corrosion was so thick that the pumps required grit blasting three times to achieve a proper profile. A solution was sorely needed.

The most severe corrosion areas were repaired with Belzona 1121 followed by two coats of Belzona 1341 to provide a long-lasting, super slick surface. The application was carried out in accordance with Belzona Know-How System Leaflets CEP-1 & CEP-10.
