# BELZONA PROTECTS CO2 ABSORBER TOWER

ID: 5232

CO2 Absorption tower 41m high, 4m diameter - lower part

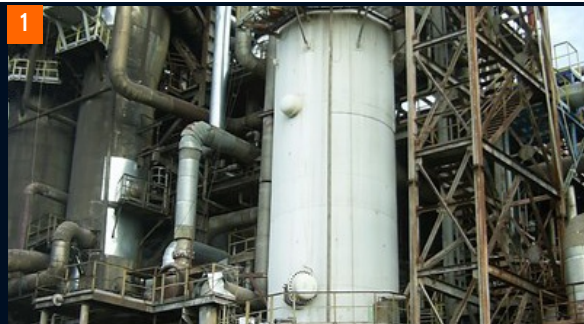
1. General view of the tower 2. Severe pitting was revealed after surface preparation by abrasive blasting 3. Application of the first coat of Belzona 1391 underway 4. View of the final application. Belzona 1391 was applied in two coats with grit blasting between the first and the second coat
