# BELZONA REPAIRS HIGH VOLTAGE BREAKER

ID: 5233

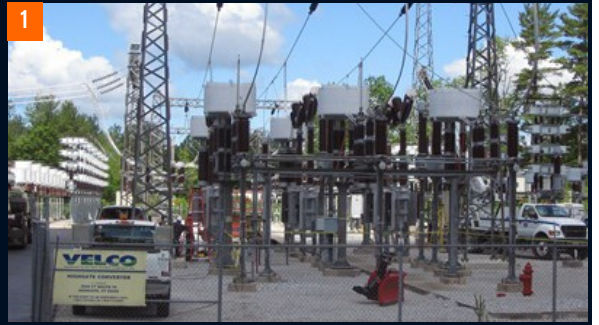
The aluminum casting on a SF6 High Voltage Breaker cracked, causing coolant to leak out and create a dangerous operating situation. Dismounting and replacing the breaker was not an option as no spare breaker was available for months.

1. Overview of the converter station
2. The leaking area
3. Completed surface preparation
4. Completed application

The surface preparation was carried out with a hand tool grinder and the application was done in accordance with Belzona Know-How System Leaflet TCC-1.
