# BELZONA PROTECTS SPRAY CASTER FAN

ID: 5234

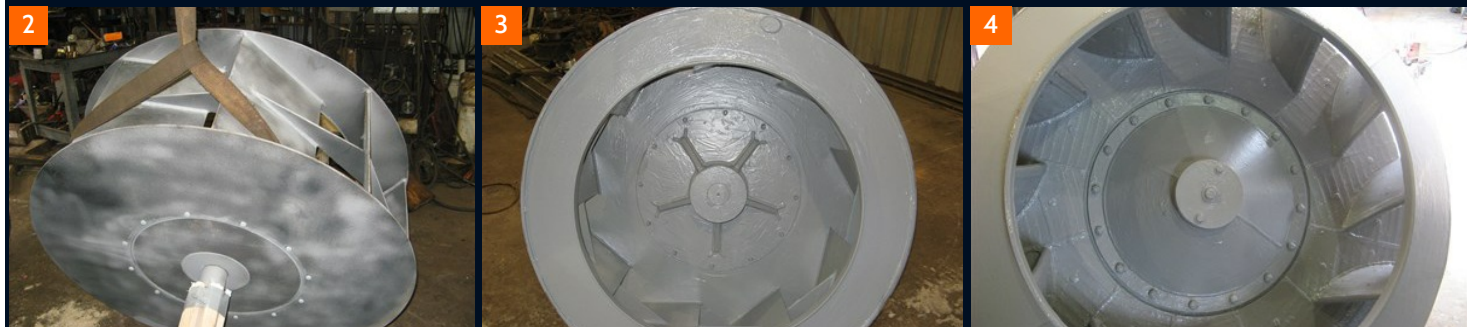
Pitting, erosion, corrosion, delamination and accumulation of dirt from the humidity prematurely degrades the life expectancy of the fan blades. Additionally, cleaning and balancing are difficult due to dust penetration and clinging to the blades.

1. Spray Chamber Caster Fan showing pitting, corrosion
2. Impeller fan blade after grit blasting
3. Spray caster with first coat of Belzona 5891
4. Bottom of spray caster wheel after second coat of Belzona 5891

Application was carried out in accordance with Belzona Know-How System Leaflet FBC-2 and the IFU for Belzona 5891. Fan was grit blased with sand, cleaned with Belzona 9111 and two coats of Belzona 5891 applied.

Belzona 5891 HT was selected because it met the temperature exposure limits as well as the chemical exposure contained in the water. Customer has coated two fans that are still in service today. Previously, they were replacing spray caster fans every 18 months.
