# BELZONA PROTECTS NEW BEARING WHEEL

ID: 5235

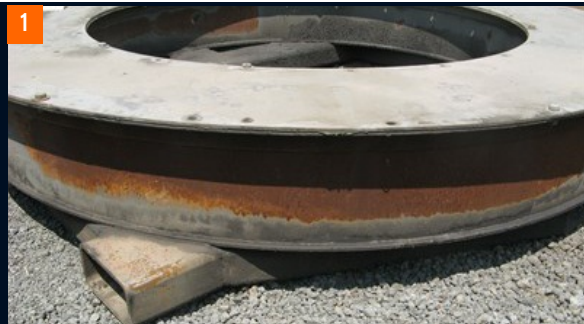
1. New bag house bearing wheel
2. Bearing wheel seat after grit blasting and degreasing
3. Bearing wheel seat with 2 coats of Belzona 5811
