# ABRASION CONTROL ON STEEL BENT ELBOW PIPES WITH BELZONA

ID: 5236

Support base of steel bent elbow pipes in a bag house exhaust room of a steel manufacturing facility.

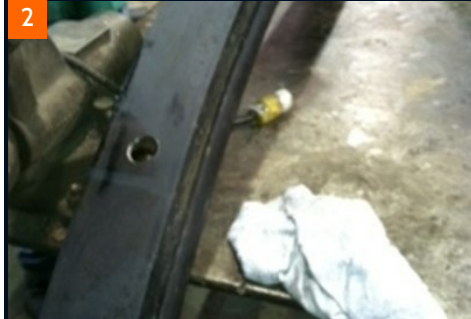
Original steel pipes are built with a 2"x4" steel base that supports the bottom of the bent steel pipe. Heavy abrasion discharge from dust and mill operation particles penetrate the cylindrical steel wall surface and erode the base requiring pipe replacement or extensive welding.

1. Steel bent discharge pipe in operation
2. Bent dust discharge pipe pre-drilled hole portal
3. Bent dust discharge pipe filled with Belzona 1391
4. Bent discharge pipe plugged prior to cure of 1391

Base 2" x 4" x 8' in length had to have a portal hole drilled in order to pour the material and allow it to fill the cavity of the base. Belzona two part material was mixed and poured to fill spaces. Prior to full cure, the portal holes were filled with a screw that was additionally sealed by the Belzona 1391.
