# BELZONA PROTECTS CONCRETE CONTAINMENT BASIN

ID: 5237

Outdoor Concrete Containment Basin

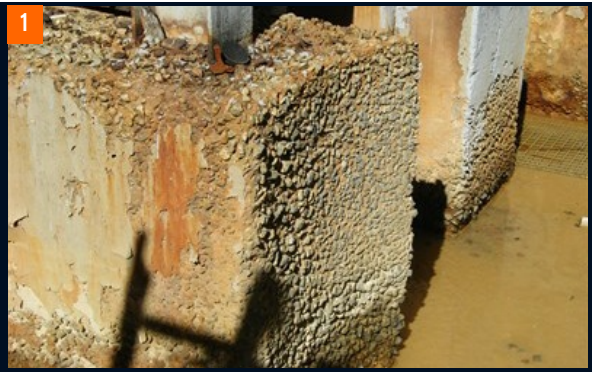
Aggressive chemicals, aluminum chloride, aluminum chlorhydrate, ferric acid and hydrogen chloride destroyed the concrete after many years of service at this plant. The tank foundation support, walls, floors and drain bunds need protection from these chemicals.

1. Column support uncoated and exposed to chemical penetration and erosion.
2. Newly poured concrete containment area.
3. Concrete tank support area with 4311 applied.
4. Completed containment area after 2 coats.
