# BELZONA PROTECTS CONCRETE FLOOR FROM CHEMICAL DAMAGE

ID: 5238

Concrete floor in a Chemical Process Building

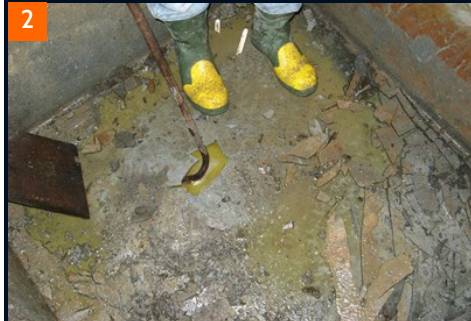
Floor, sumps and support pedestals are eroding due to sodium hypochlorate exposure to the concrete. Additionally, the sump drain has PVC which is a fire hazard and must be replaced. Chemicals will seep through the concrete into the ground if not contained.

1. Damage to concrete floor from chemical spill
2. Seepage of sodium chlorate from previous product failure where the competitive product failed on adhesion
3. pH testing of concrete after power washed and prior to coating
4. Two coats of Belzona 5811 to drain and floor

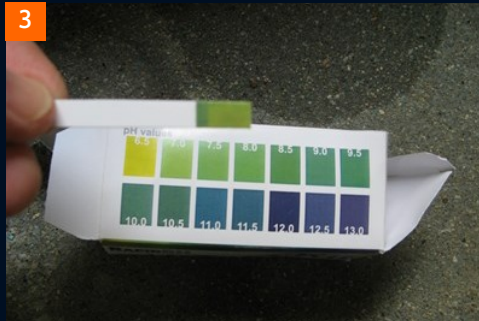
Adhesion and protection from sodium hypochlorate was the principal reason Belzona 5811 was selected. The customer had a previous coating on the sump well floor and sides that delaminated and failed due to poor adhesion.
