# BELZONA REPAIRS SUMP AT A GAS STATION

ID: 5239

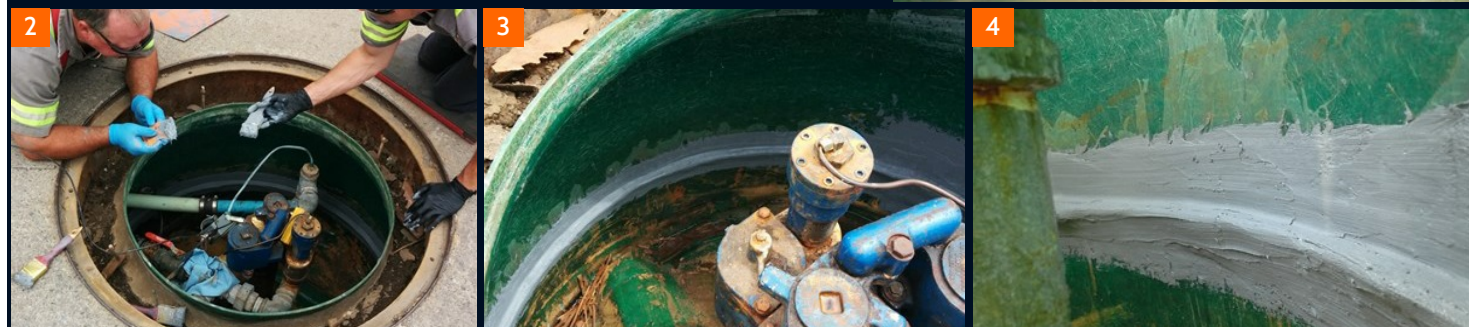
## PHOTOS

Water was flowing in through the seams inside the sump.

1. Prior to application
2. Application in progress
3. Completed application
4. Completed application

The application was carried out in accordance with Belzona Know-How System Leaflet TCC-1 for sealing cracks, porous welds, bolted and riveted joints. The area was prepared by roughing the surface. Belzona 1291 was applied by forcing the mixed material into the cracks and holes and Belzona 9341 was applied. Belzona 1161 was applied to the seam of the sump.

Belzona 1291 sealed the holes and cracks and stopped the water from leaking through. This is a rapid curing epoxy repair paste that is water resistant and will adhere to wet surfaces. Belzona 1161 is a water and oil tolerant paste grade product that will cure under water. This will prevent galvanic corrosion. It will not corrode and it has a good chemical resistance.
