# PIPE REPAIR ON TANK

ID: 524

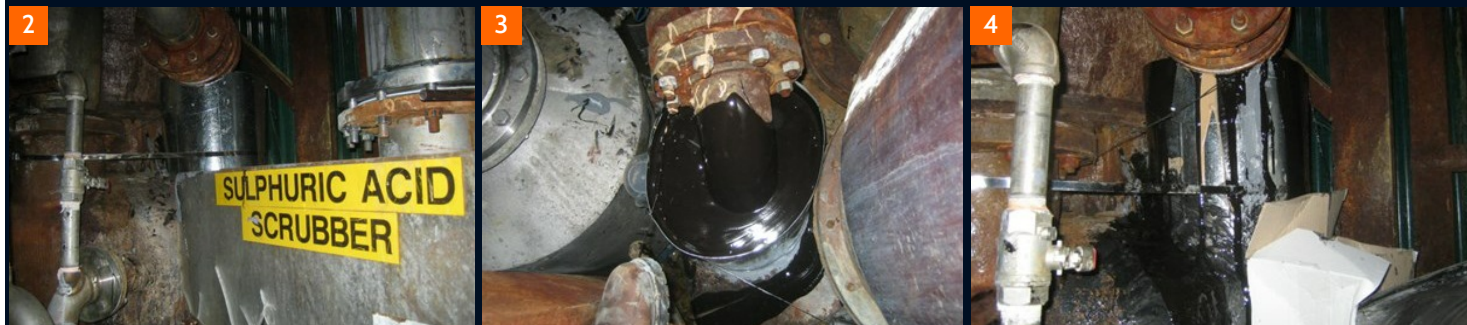
## PHOTOS

Fiberglass outlet pipe on tank developed a new leak. Sulfuric acid in steam.

1. Former for pipe was installed
2. Belzona 1221 put in place to dam the leak through areas
3. Belzona 5811 was mixed and poured into former
4. Finished job

Application was carried out in accordance with a modified version of Belzona Know-How System Leaflet VPF-11a
