# BELZONA PROTECTS POWER PLANT CONDENSERS

ID: 5241

Water boxes and tube sheets of two power plant condensers.

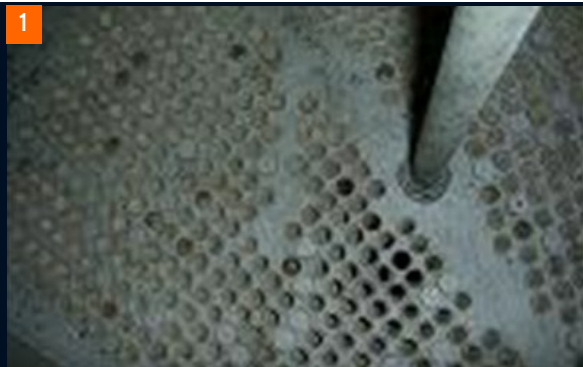
Corrosion/erosion on the turbine condensers (heat exchangers) after years of operation. Originally un-lined, extensive bimetallic corrosion had occurred between brass tubes and carbon steel tube sheets.

1. Surface preparation of tube sheet by blast cleaning 2. Coating of tube sheet with Belzona 1321 3. Application of first coat of Belzona 1341 to water box 4. Completed application to tube sheet and water box

Application was carried out in accordance with Belzona Know-How Leaflet HEX-3. Belzona® 1321 was used to protect tube sheets from bimetallic corrosion and erosion from entrapped particles in the cooling water. Belzona® 1341 was used to protect the water boxes.
