# BELZONA RETURNS CONVEYOR BELT TO SERVICE

ID: 5244

Conveyor belt at a recycling center.

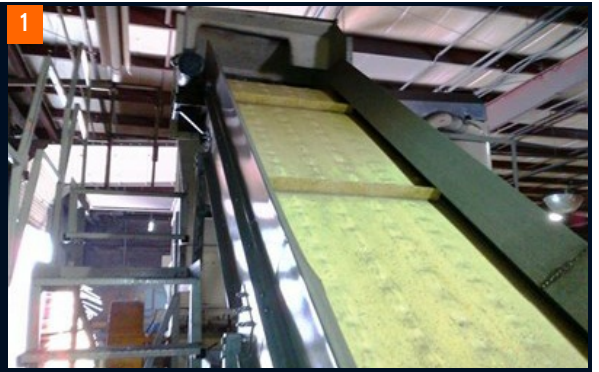
1. Conveyor belt
2. Prior to application
3. Completed application

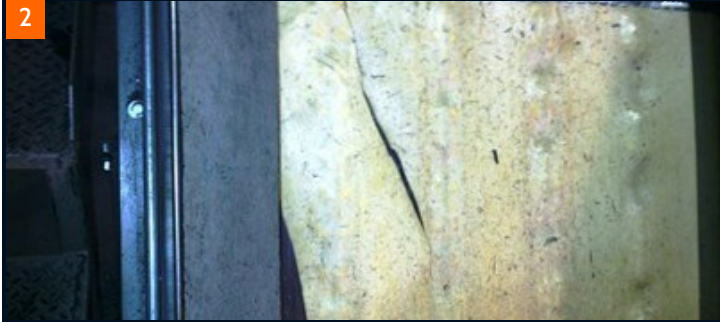
The conveyor belt had torn and was taken offline until it was repaired.

The application was carried out in accordance with Belzona Know-How System Leaflet SHM-1 for repairing ripped, torn and worn conveyor belts. The surface was prepared by removing any worn fabric or torn rubber and using a rotary wire brush to abrade the surface, producing a wooly surface. Belzona 9111 was used to clean the entire area. Belzona 2911 was applied to the prepared surface area and Belzona 2211 was brush applied to the surface area.
