# BELZONA CREATES IRREGULAR SHIM FOR DRAGLINE ROTATING BLOCK

ID: 5247

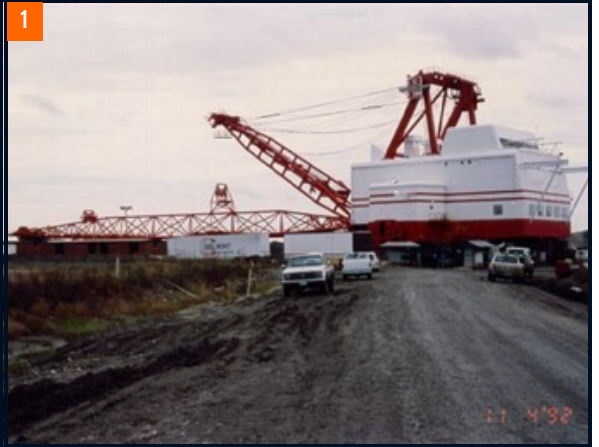
1. View of Dragline Equipment
2. Injection ports in place
3. Injection gun filled with Belzona 1341
4. Injection in progress

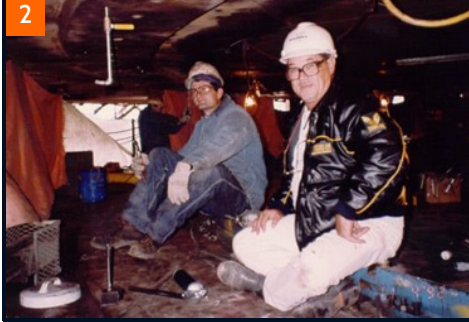
The base of the rotating block had worn unevenly creating an uneven mounting surface.

Application carried out in accordance with a modified version of Belzona Know-How System Leaflet GSS-1
