# BELZONA REDUCES DOWNTIME FOR CONCRETE BRIDGE EXPANSION JOINT REPAIRS

ID: 525

Steel armored expansion joint on a busy interstate/highway bridge.

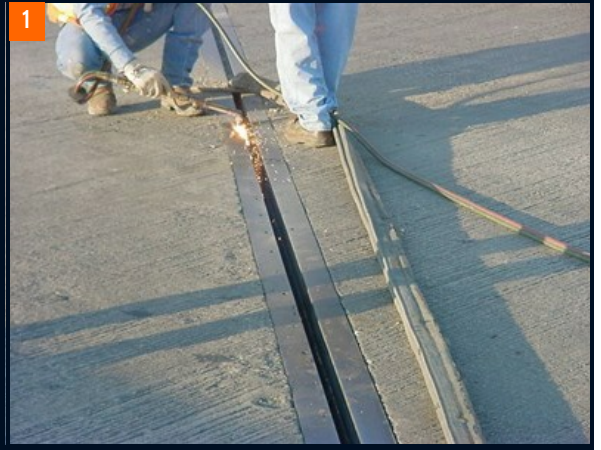
1. Steel armor being cut off.
2. Concrete edges blasted. Old rubber seal will be used as backer rod for Belzona 4521.
3. Belzona 4111 being troweled and packed.
4. Completed repair.
