# HD CLEANER CONE REPAIRED WITH BELZONA

ID: 5252

High Density (HD) cleaner cone.

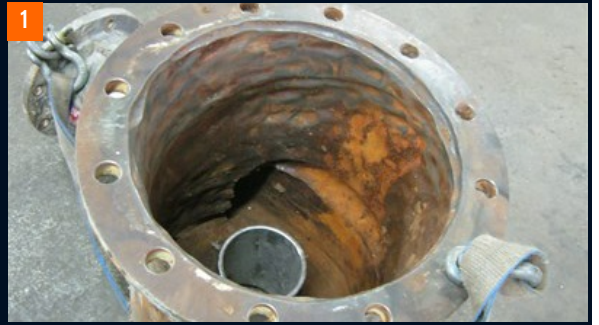
Abrasion caused by removal of unwanted solids from pulp paper.

1. Prior to application
2. Application in progress
3. Application in progress
4. Completed application
