# BELZONA SAVES TIME AND REDUCES COSTS WITH BUSHING REPAIR

ID: 5256

Loader arm bush housing.

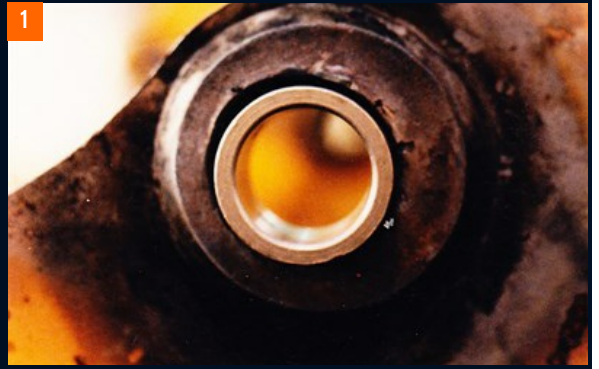
The loader arm bush housing was worn oversize. Welding and boring would require removing the arm.

1. Loader arms showing wear
2. Grinding the housing
3. Belzona 9411 on new bushing, grease groove full of wax
4. New bushing in place
