# BELZONA REPAIRS RUBBER TRACK

ID: 5257

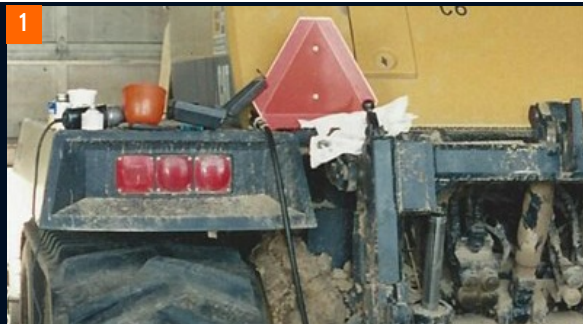
1. Caterpillar showing track
2. Close up of the cut in the track
3. Prepared and conditioned cut
4. Completed application

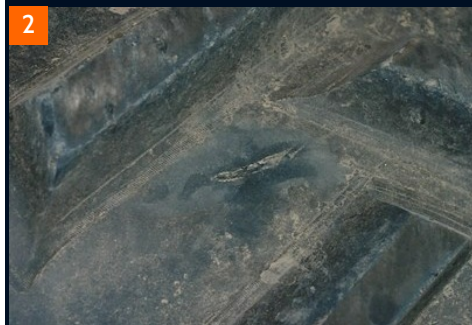
The exposed fabric will wick in water and rot, causing the track to weaken and require replacement.

The rubber track was cut open, exposing the fabric.
